# ***SAFETY ALERT***

## **Helicopter Landing Sites: Free from Debris**

***Foreign object debris can foul rotor systems and cause damage***

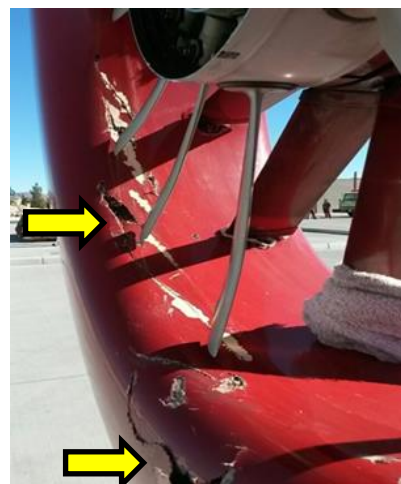
- The pilot of an Airbus (formerly Eurocopter) EC135 P2+ helicopter reported that, while landing at a public safety training center, he felt the helicopter shudder unexpectedly. The pilot immediately landed the helicopter without further incident. A postflight examination revealed that a towel had been ingested into the fenestron (see figures 1 and 2). The towel ingestion resulted in separation of the fenestron hub cover, which was subsequently ingested, substantially damaging the helicopter. The pilot reported that the towel came from an unsecured storage container near the landing site. ([GAA16LA056](#))

**Figure 2.** Lower fenestron housing.

- When choosing a landing site, avoid areas close to construction activities and trash storage. Consider the effects of main rotor system downwash and upwash on FOD migration when selecting a landing site, based on the site conditions and the size of the helicopter.

- Keep in mind that wind speed and direction can aid in the migration of FOD to landing sites. Rain water and drainage can also stream FOD along the path of least resistance.

- Ask available personnel to conduct a sweep of the landing site for FOD that could affect the helicopter. If personnel are not available, visually scan for FOD on the landing site while conducting your high and low reconnaissance before you land. If the conditions permit, check for FOD while conducting your ground reconnaissance before you take off.

- Have personnel at the landing site remove or secure any headgear (such as helmets, hats, and knit caps). Ensure any additional clothing, gear, and equipment items are secured and kept clear of the main and tail rotor systems.
